Use Attainability Analysis  
for  
WBID 2041 Dry Fork Creek

Submitted by  
SES Inc.  
to  
Missouri Department of Natural Resources  
Water Protection Program

**Field Data Sheets for Recreation Use Stream Surveys**  
**Data Sheet A - Water Body Identification**  
(For water body being surveyed)

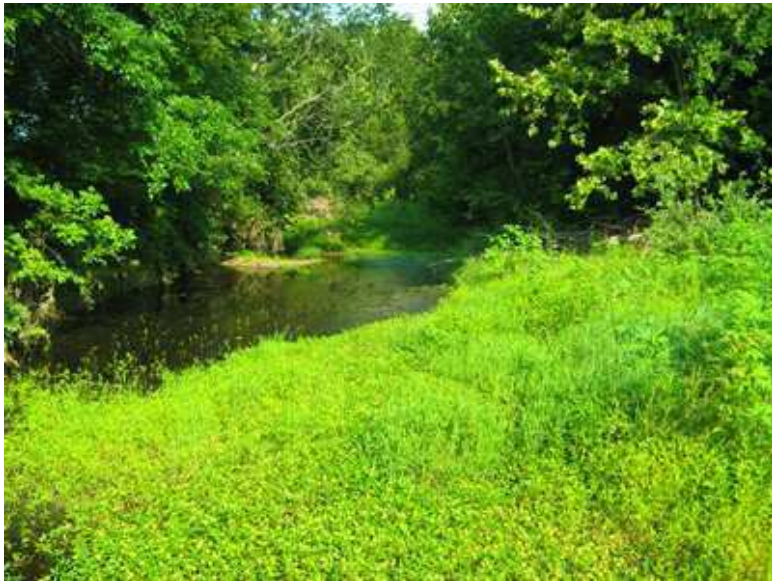
**Site# 1 Photo ID# 3, Upstream**

**WBID #** 2041      **Site #** 1  
**Mark #** 8      **Dissolved Oxygen (ppm)** 8.4  
**Upstream Views Physical Dimensions:** Is there any water present at this view? yes  
 If so, is there an obvious current? no

% of Channel Feature				
Riffle	10				
Run	0				
Pool	90

28% Cobble	45% Gravel	% Sand	% Silt
% Mud/Clay	27% Bedrock

30% floating and flowering water plant. 30% floating algae

Odor	Sewage	Musky	Chemical	<u><b>None</b></u>	Other
Color	<u><b>Clear</b></u>	<u><b>Green</b></u>	Gray	Milky	Other
Bottom Deposit	Sludge	Solids	Fine Sed.	<u><b>None</b></u>	Other
Surface Deposit	<u><b>Oil</b></u>	Scum	Foam	None	Other

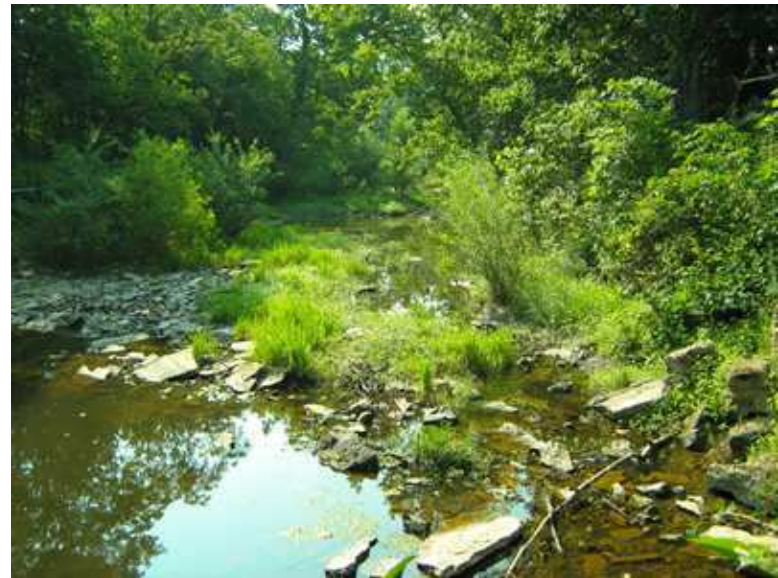
**Site# 1 Photo ID# 4, Downstream**

**Downstream View's Physical Dimensions:** Is there any water present at this view? yes  
 If so, is there an obvious current? no

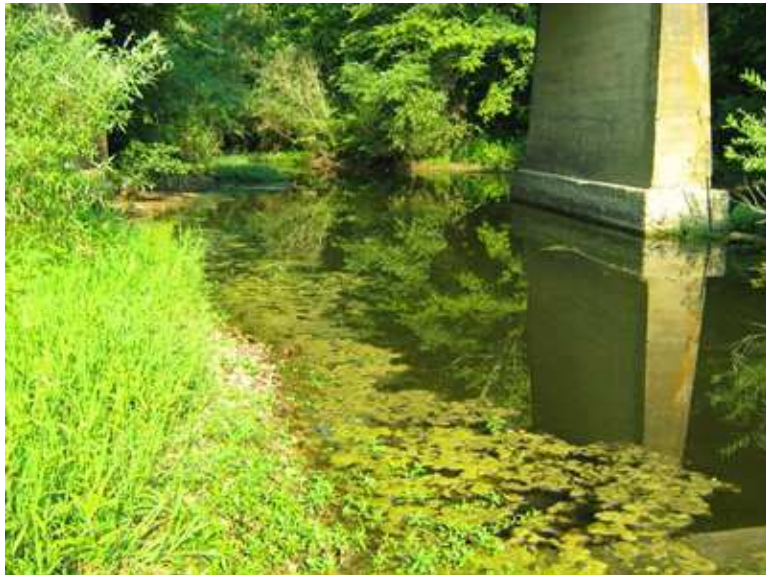
**Site# 2 Photo ID# 1, Upstream**

**WBID #** 2041      **Site #** 2  
**Mark #** 7      **Dissolved Oxygen (ppm)** 3.6  
**Upstream Views Physical Dimensions:** Is there any water present at this view? yes  
 If so, is there an obvious current? no

% of Channel Feature				
Riffle	50				
Run	0				
Pool	50

100% Cobble	% Gravel	% Sand	% Silt
% Mud/Clay	% Bedrock

algae on substrate, blooming in water and floating on water surface. Water in channel is almost non-existent and mostly grown over with willow.

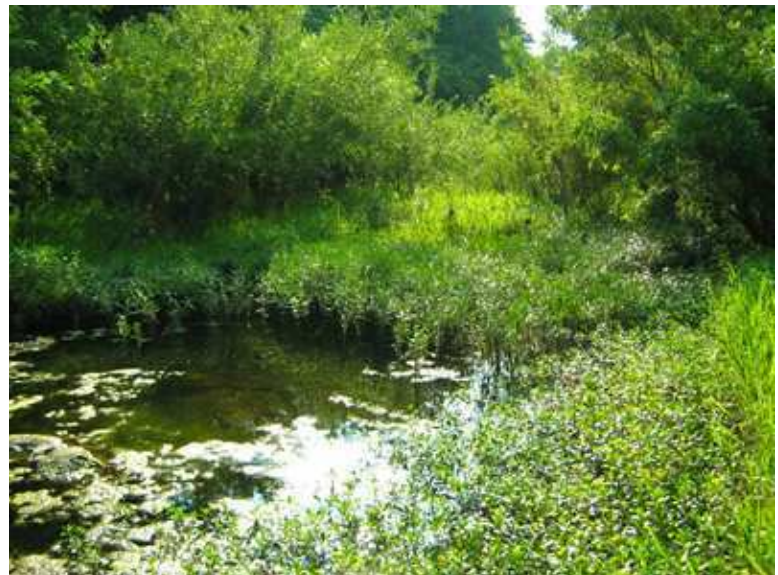
**Site# 2 Photo ID# 2, Downstream**

**Downstream View's Physical Dimensions:** Is there any water present at this view? yes  
 If so, is there an obvious current? no

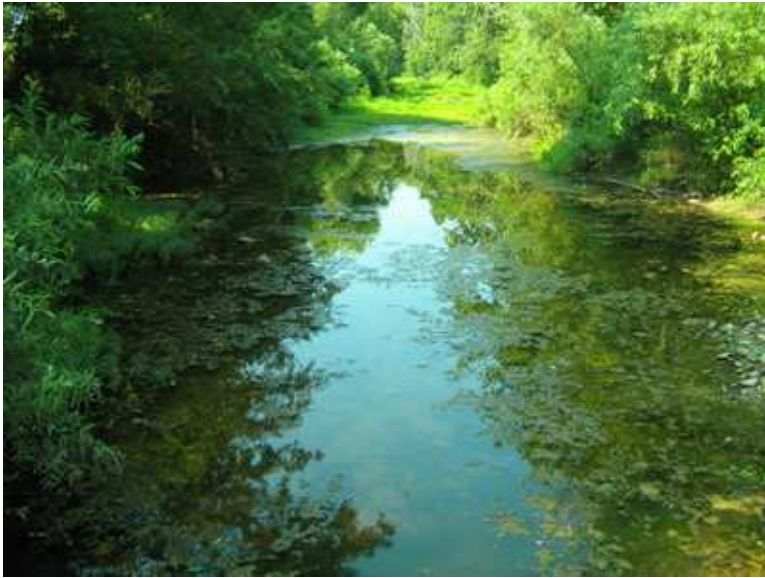
**Site# 3 Photo ID# 6, Upstream**

**WBID #** 2041      **Site #** 3  
**Mark #** 9      **Dissolved Oxygen (ppm)** 4.7  
**Upstream Views Physical Dimensions:** Is there any water present at this view? yes

% of Channel Feature				
Riffle	0				
Run	0				
Pool	100

100% algae on subsurface. 25% coverage of flowering, floating water plant.

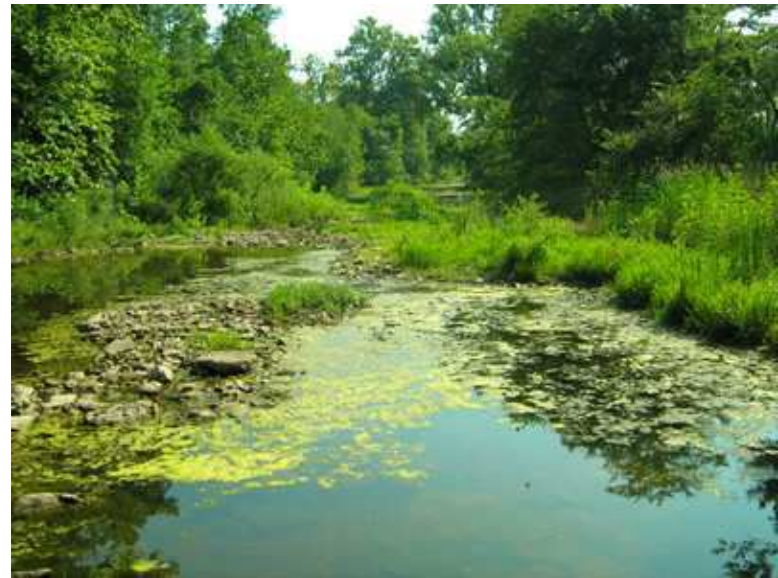
**Site# 3 Photo ID# 5, Downstream**

**Downstream View's Physical Dimensions:** Is there any water present at this view? yes

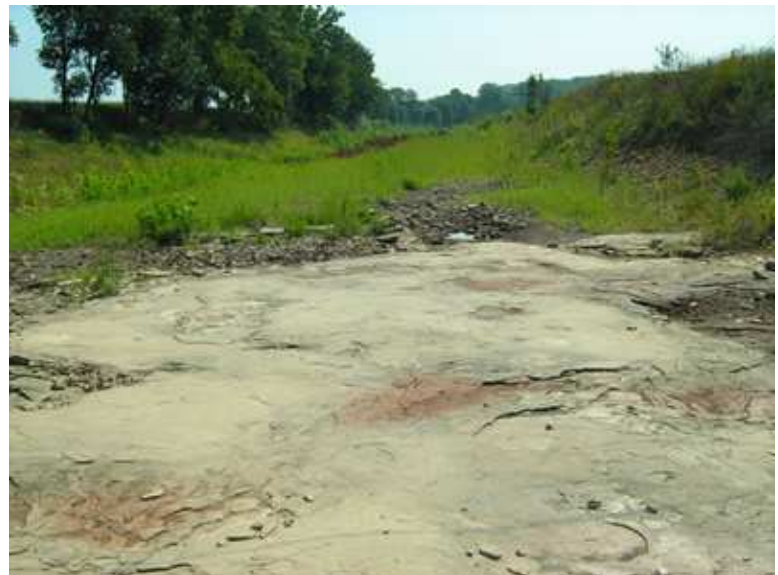
**Site# 4 Photo ID# 8, Downstream**

Downstream View's Physical Dimensions: Is there any water present at this view? no

Odor	Sewage	Musky	Chemical	<u>None</u>	Other
Color	Clear	Green	Gray	<u>Milky</u>	Other
Bottom Deposit	Sludge	Solids	Fine Sed.	<u>None</u>	Other
Surface Deposit	Oil	Scum	Foam	<u>None</u>	Other

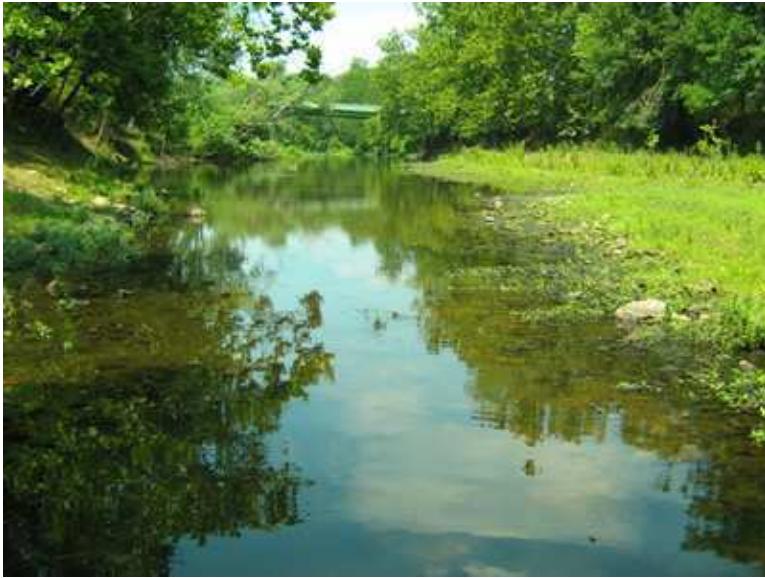
**Site# 5 Photo ID# 10, Upstream**

**WBID #** 2041      **Site #** 5  
**Mark #** 11      **Dissolved Oxygen (ppm)** 8.4  
**Upstream Views Physical Dimensions:** Is there any water present at this view? yes  
 If so, is there an obvious current? no

% of Channel Feature				
Riffle	43				
Run	0				
Pool	57

algae on 100% of substrate.

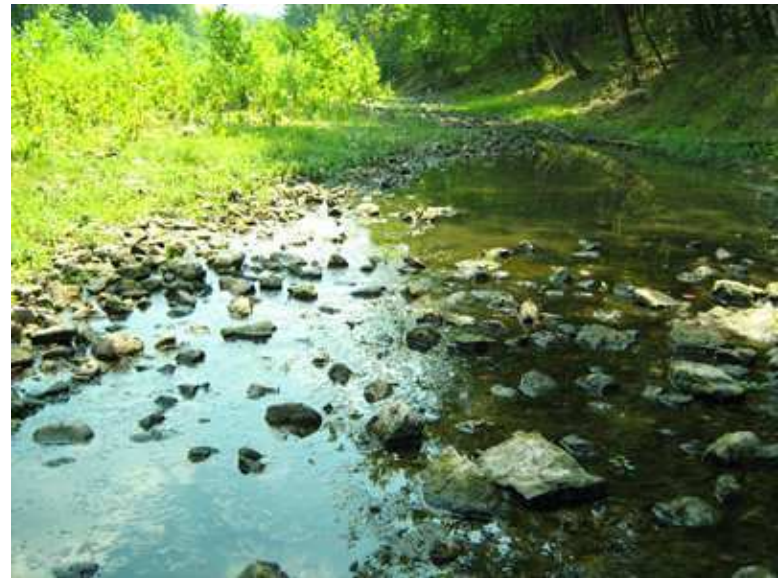
**Site# 5 Photo ID# 11, Downstream**

**Downstream View's Physical Dimensions:** Is there any water present at this view? yes  
 If so, is there an obvious current? no

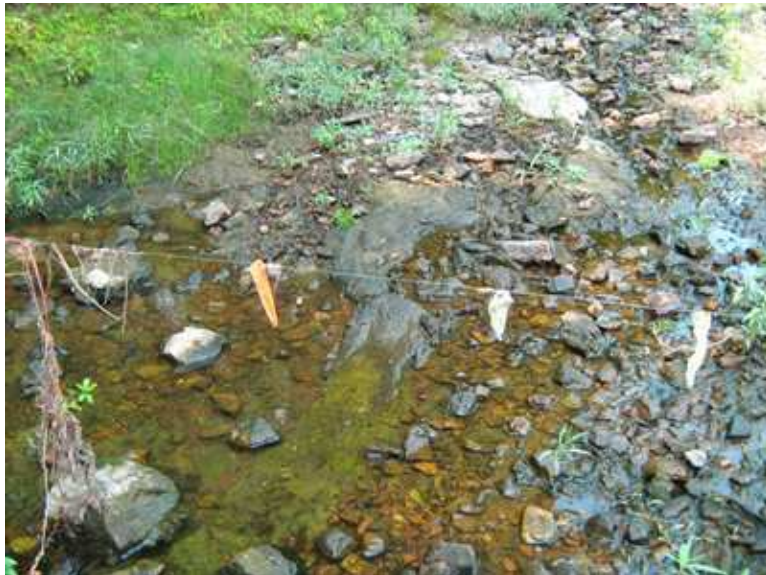
**Site# 5 Photo ID# 12, Fence**

City/county parks	Playgrounds	MDC conservation lands	Urban areas
Campgrounds	Boating accesses	State parks	National Forests
Nature trails	Stairs/walkway	No trespass sign	<u><b>Fence</b></u> <u><b>Picture #12</b></u>
Steep slopes	None of the Above	Other

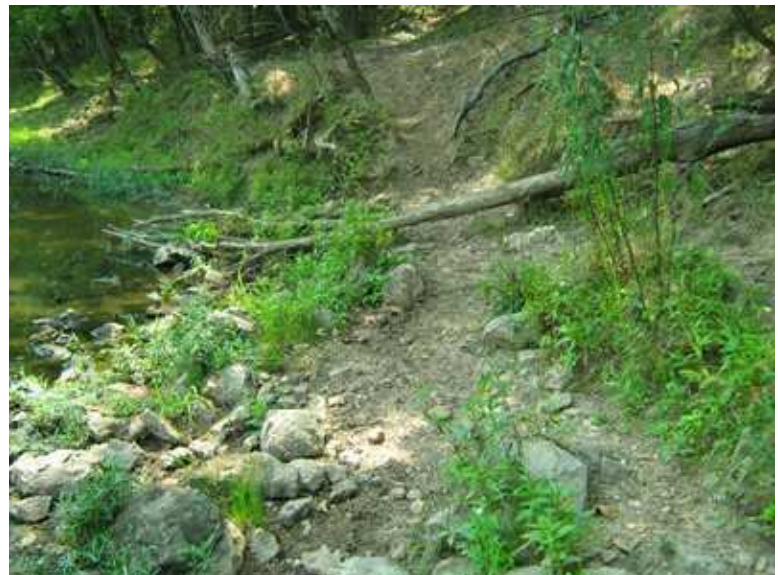
**Site# 5 Photo ID# 9, Livestock watering**

Roads	Rope swings	Foot paths/prints	Dock/platform
<u><b>Livestock Watering</b></u>	RV/ATV Tracks	Camping Sites	Fire pit/ring
<u><b>Picture #9</b></u>			
NPDES Discharge	Fishing Tackle	Other:

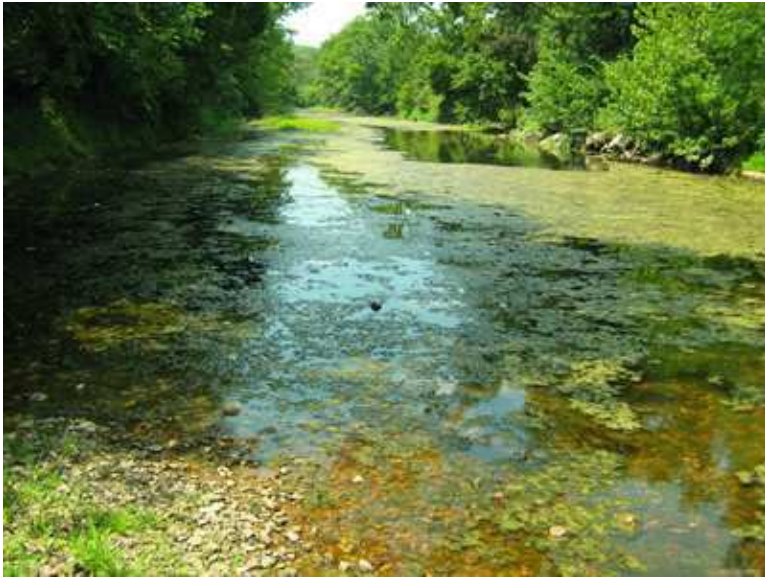
**Site# 6 Photo ID# 14, Upstream**

<b>WBID #</b>	2041	<b>Site #</b>	6
<b>Mark #</b>	12	<b>Dissolved Oxygen (ppm)</b>	5.8
<b>Upstream Views Physical Dimensions:</b>	Is there any water present at this view?      yes

% of Channel Volume				
Riffle	20				
Run					
Pool	80

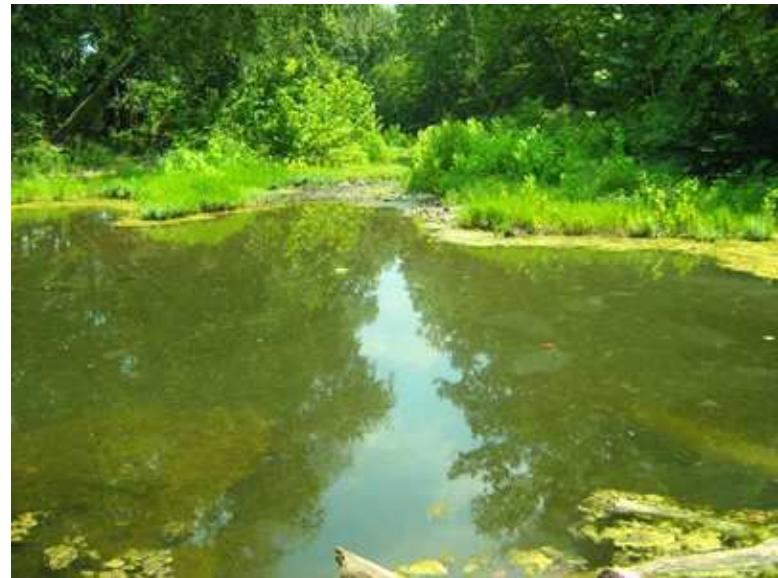
**Site# 6 Photo ID# 13, Downstream**

**Downstream View's Physical Dimensions:** Is there any water present at this view?      yes
